## Memorandum

**Re:** Wynn Resorts  
Water Damage Loss  
7th Floor Apartment  
817 5<sup>th</sup> Avenue, New York, NY

Date:	March 16, 2005
Report:	Two
Insured:	Wynn Resorts, LLC
Claim No:	Various
Policy No:	Various
York File No:	SLA-0151A9
Loss Location:	817 5 <sup>th</sup> Ave., New York, NY
Policy Period:	6/22/2004 - 2005
Type of Claim:	Water Damage
Date of Claim:	12/29/04

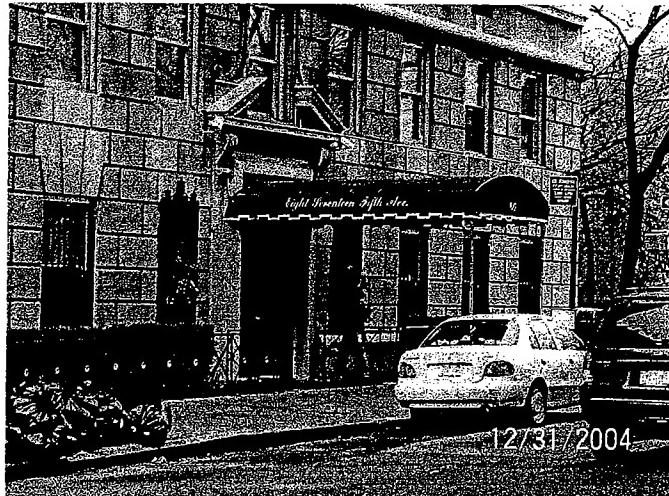
EXTERIOR OF RISK

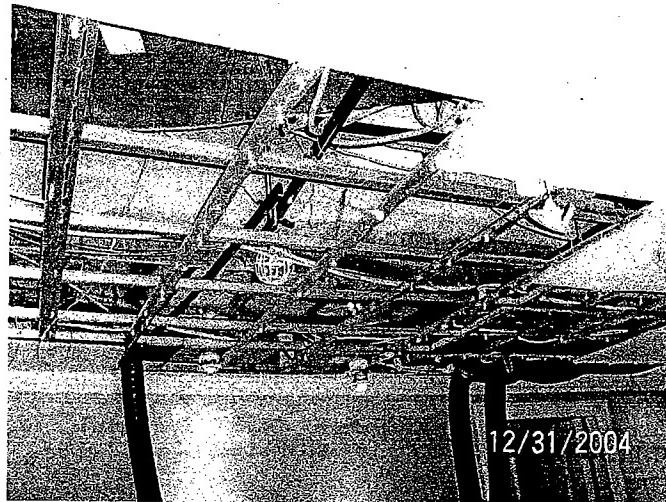
This room has the most serious damage.

MAIN HALLWAY CEILING WITH DRYWALL REMOVED

Replace all of the sheetrock ceiling and insulation. The two-piece crown molding will need to be removed to accomplish this.

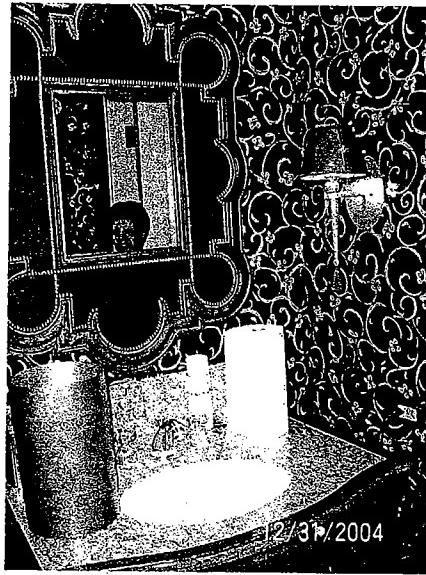
This room was located next to the small closet where most of the water entered the apartment. The wall fabric was still wet when I examined it, and the ceiling and insulation were still in place but obviously damaged to the point that it had to be replaced. Your consultant from Hillman Environmental recommended that the ceiling and the fabric walls be removed to allow for the property drying of this room.

POWDER ROOM WALL FABRIC IN THE AREA WHERE THE WATER ENTERED THE ROOM

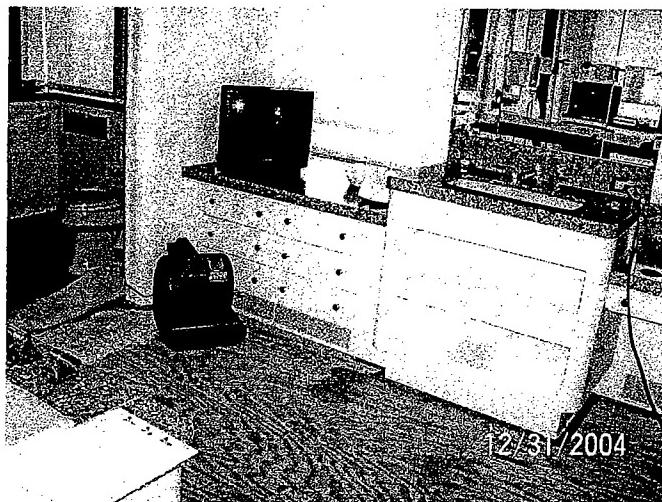
Only the carpeting in these rooms was damaged, and it had already been removed and thrown out by the time I arrived.

BATH ROOM WITH CARPETING REMOVED

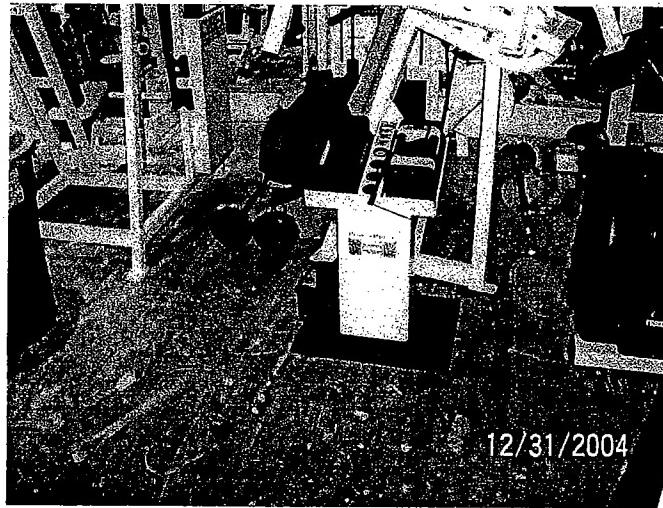
EXERCISE ROOM WITH CARPETING REMOVED
